Fixed: Instrument panel rheostat by [Jetfever](#) » Wed Sep 09, 2009 3:40 pm

I suffered Instrument panel rheostat failure. None are available worldwide. (part # SPEC36232) and this part is obsolete. Many have drilled a new instrument panel hole, and installed a toggle for the nav lights, and a "new" rheostat.. (Jan, 2009 SWP News). This part # is for the entire Nav/ rheostat assembly.

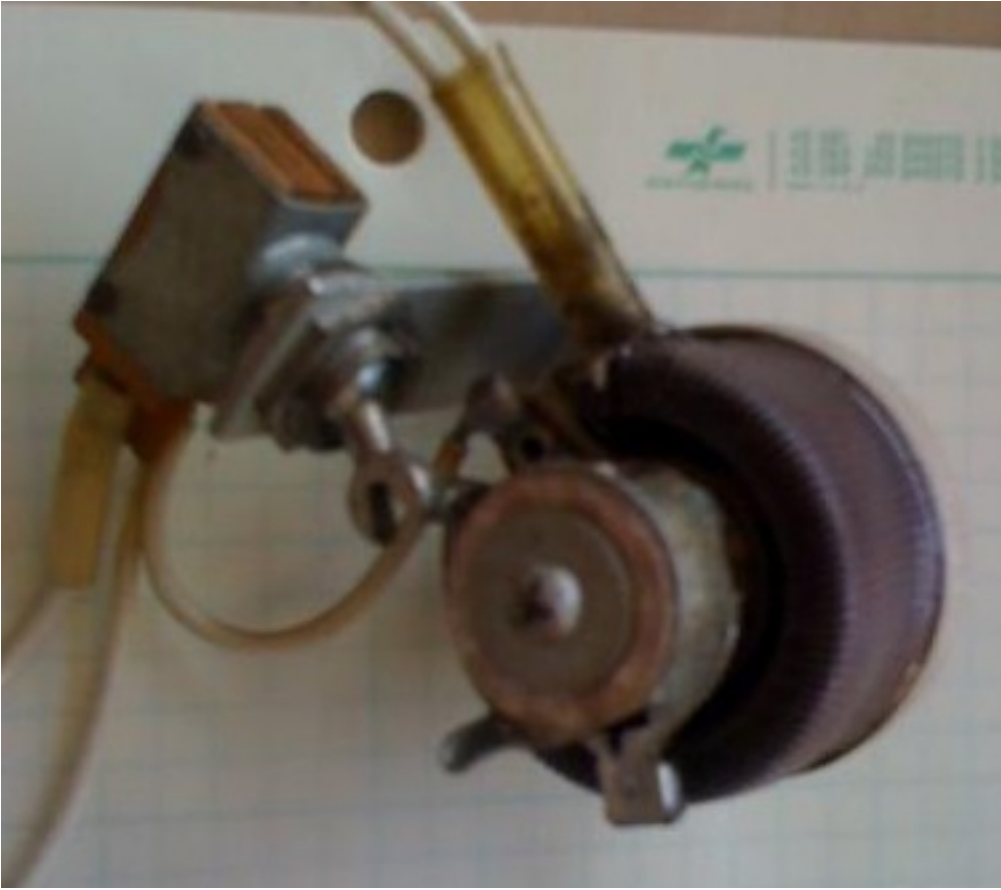
Solution: I took the new OHMITE rheostat apart, it is easy, just remove the circlip. I placed the new center steel shaft in a lathe, and then drilled/tapped the aft end for the fastener (screw) and the "activator". (First photo, "activator lever is at 7 o'clock). I re-used the activator donated from the old burned out rheostat.

So simply re-use the steel shaft from the old burned out rheostat and the old activator, screw and washers. This old steel shaft should have little to no wear on it.

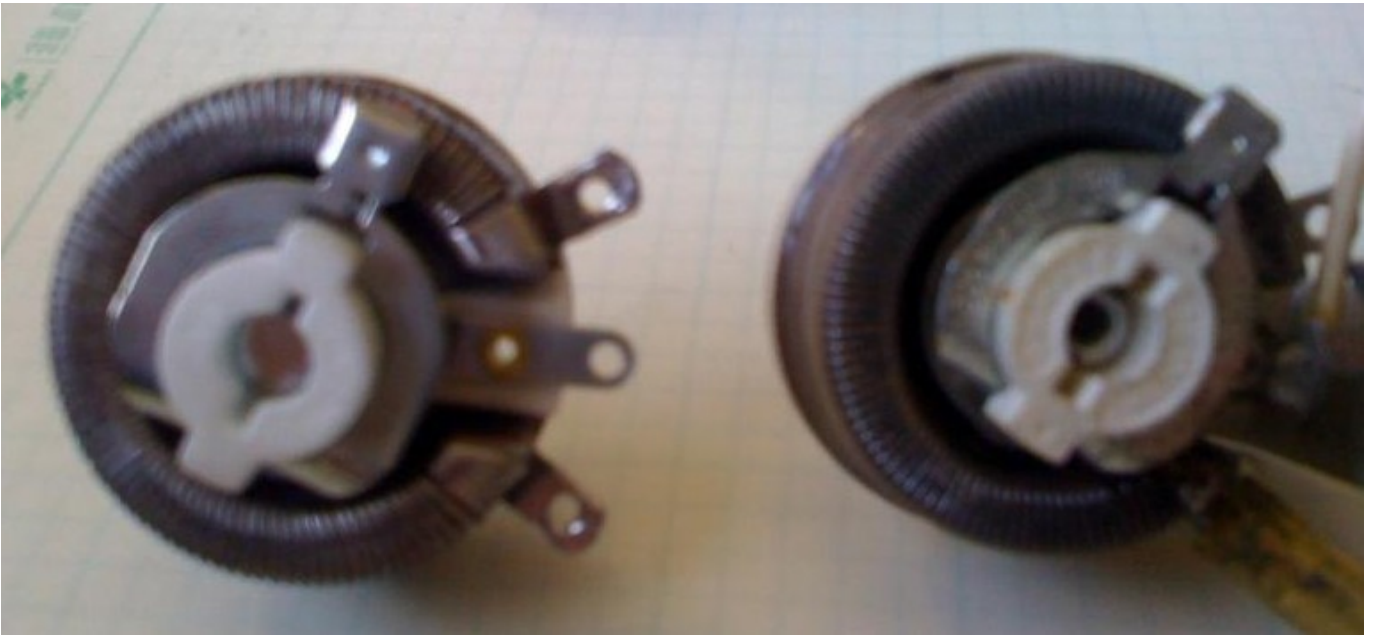
PROBLEM: New rheostat (lower photo, on the left) is NOT threaded on the aft side for the Nav light toggle "activator", a simple device.
