Fuel Sender/Gasket Replacement

Model & year: **92-98 E36 (318, 325, 328, M3)**

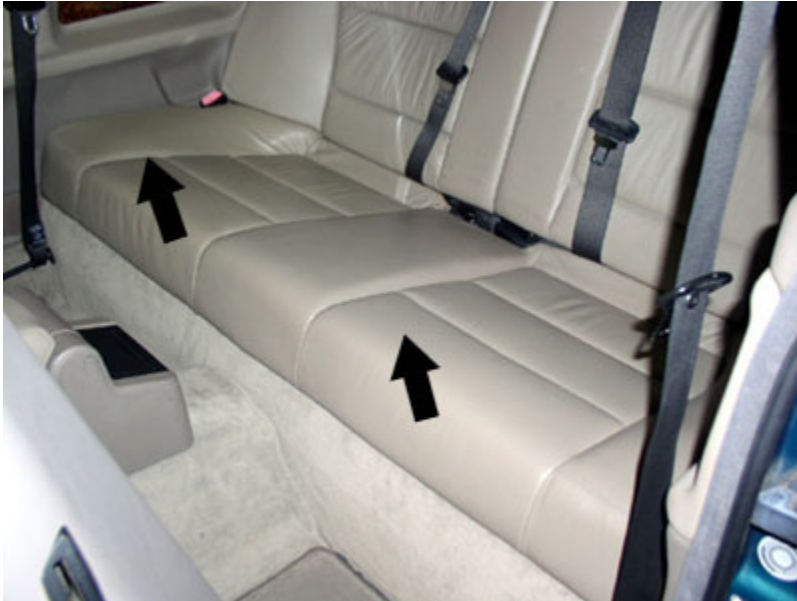
1) Lift up on front of rear seat and remove. See image below.

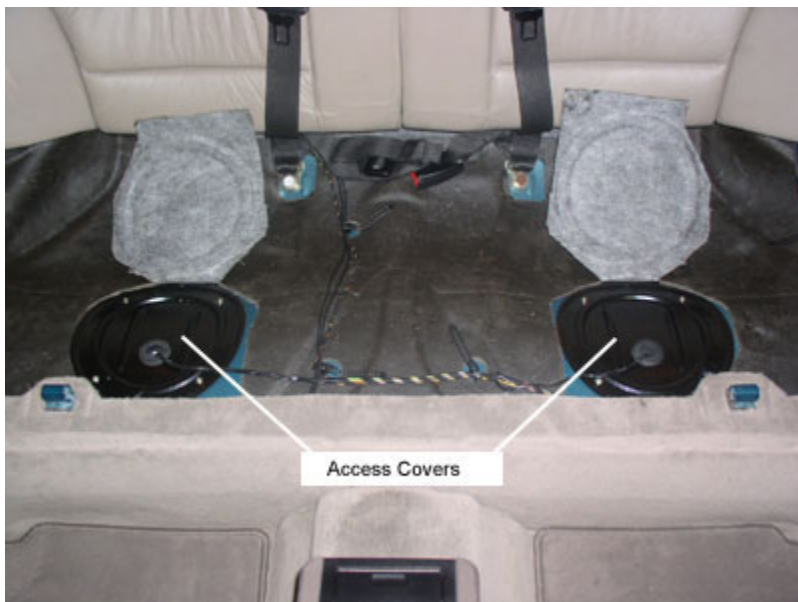
2) Lift up insulation to reveal access covers. Using phillips screwdriver, remove both access covers then unplug electrical connector(s). See image below.

3) Check for fuel pooling in center of sender units or fuel leaking around gaskets and running down tank. The former indicates cracked sender units, the later a bad gasket.
